**Flood Control Project Maintenance
Levee Inspections**
LMA District Cover Sheet
Spring 2019 Levee Inspection Results

Solano County Public Works Mellin Levee

Levee Inspection Report By Mile - Spring 2019

Waterway	Bank	Unit Miles	Inspection Start/End	Inspector
Unit No. 01 Mellin Levee	Right	0.59	03/28/2019 03/28/2019	David Julian

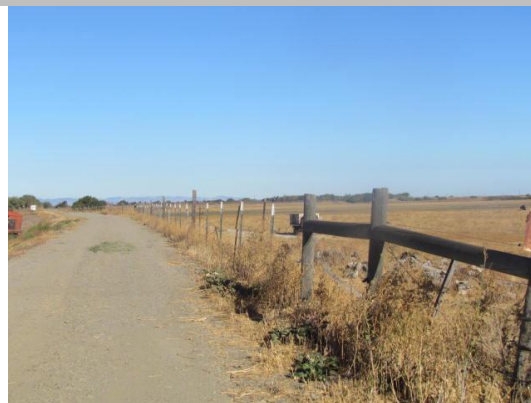
Photo 1 of 1 : SP_2019_NA0012_258_3_20190311_00002.jpg

LM Start	0.01	Rating **	M	Issue No.	3
LM End	0.59	Issue Type +	En	Location *	WS
Category	Earthen Levee			GPS Latitude/Longitude	
				Start	End
Item	Encroachments			38.174167 °	38.180084 °
				-121.674312 °	-121.681992 °
DWR ID	DWR_NA0012_01_s_2012_3				
Comment Code					
FE : Fence					
Inspector Comment					
A fence is located on the waterside shoulder.

Looking west at fence on waterside shoulder.

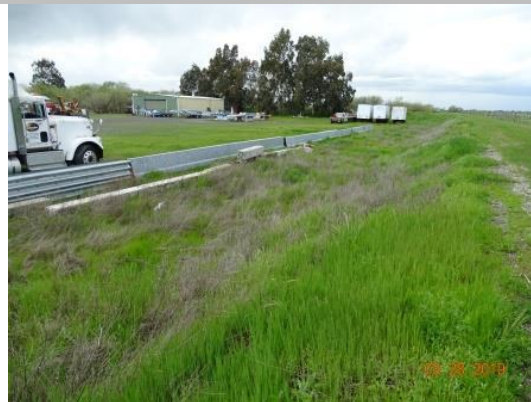
Photo 1 of 1 : SP_2019_NA0012_258_2_20190329_00006.jpg

LM Start	0.02	Rating **	M	Issue No.	2
LM End	0.37	Issue Type +	Ma	Location *	LS
Category	Earthen Levee			GPS Latitude/Longitude	
				Start	End
Item	Vegetation			38.174202 °	38.177746 °
				-121.674435 °	-121.679021 °
DWR ID	DWR_NA0012_01_s_2019_2				
Comment Code					
V1 : Control annual grass and weeds on the levee slopes and easements.					
Inspector Comment					
Maintain the annual vegetation on the landside slope.

View of annual vegetation on the landside slope (Spring 2019).

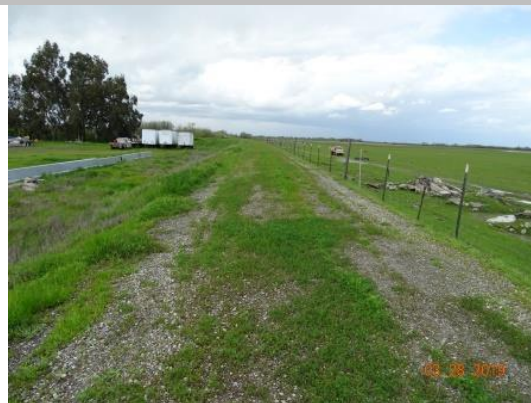
Photo 1 of 1 : SP_2019_NA0012_258_8_20190329_00007.jpg

LM Start	0.02	Rating **	M	Issue No.	8
LM End	0.59	Issue Type +	Ma	Location *	CR
Category	Earthen Levee			GPS Latitude/Longitude	
				Start	End
Item	Vegetation			38.174201 °	38.180059 °
				-121.674441 °	-121.681966 °
DWR ID	DWR_NA0012_01_s_2019_8				
Comment Code					
V1 : Control annual grass and weeds on the levee slopes and easements.					
Inspector Comment					
Remove the annual vegetation from the crown.

View of vegetation on the crown (Spring 2019).

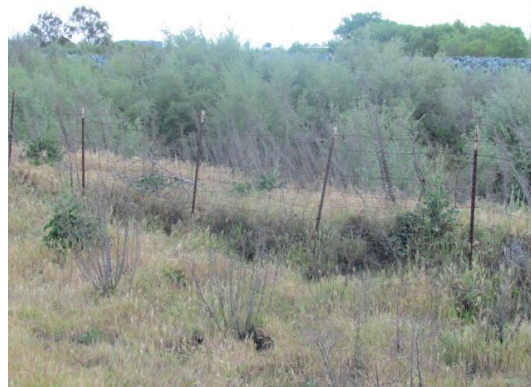
Photo 1 of 1 : SP_2019_NA0012_258_4_20190311_00003.jpg

LM Start	0.10	Rating **	M	Issue No.	4
LM End	0.28	Issue Type +	En	Location *	LS
Category	Earthen Levee			GPS Latitude/Longitude	
				Start	End
Item	Encroachments			38.175115 °	38.176805 °
				-121.675463 °	-121.677893 °
DWR ID	DWR_NA0012_01_s_2012_4				
Comment Code					
FE : Fence					
Inspector Comment					
A fence is located on the landside shoulder.

Looking southeast at fence on landward slope.

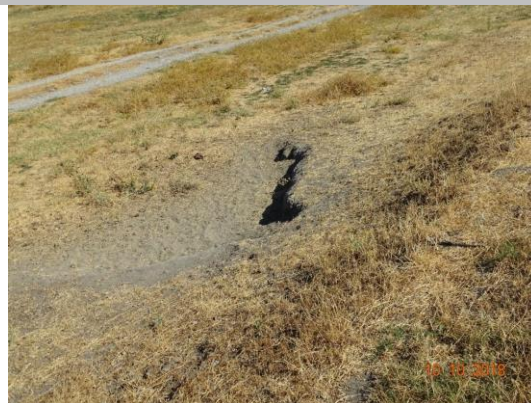
Photo 1 of 1 : SP_2019_NA0012_258_11_20190311_00005.jpg

LM Start	0.13	Rating **	U	Issue No.	11
LM End	0.13	Issue Type +	Ma	Location *	WS
Category	Earthen Levee			GPS Latitude/Longitude	
				Start	End
Item	Slope Stability			38.175355 °	38.175355 °
				-121.675833 °	-121.675833 °
DWR ID	DWR_NA0012_01_f_2018_11				
Comment Code					
S2 : Repair the levee slope damaged by foot traffic and prevent access where possible.					
Inspector Comment					
Cows are digging into the waterside toe.

View of erosion into waterside toe (October 2018).

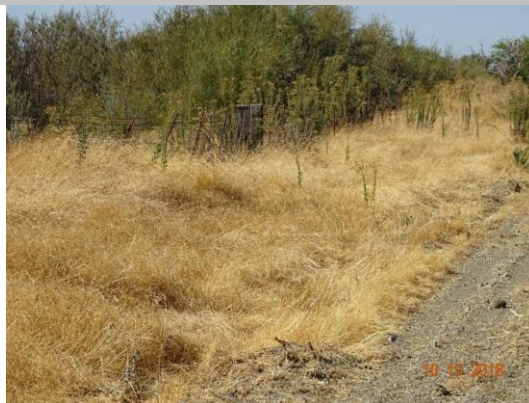
Photo 1 of 1 : SP_2019_NA0012_258_5_20190311_00004.jpg

LM Start	0.18	Rating **	U	Issue No.	5
LM End	0.25	Issue Type +	Ma	Location *	LS
Category	Earthen Levee			GPS Latitude/Longitude	
				Start	End
Item	Vegetation			38.175925 °	38.176615 °
				-121.676618 °	-121.677528 °
DWR ID	DWR_NA0012_01_f_2018_5				
Comment Code					
V1 : Control annual grass and weeds on the levee slopes and easements.					
Inspector Comment					
Remove vegetation up to fence on the landside slope.

View of vegetation on the landside slope (October 2018).
